# CARBON FOOTPRINTING AND ENERGY EFFICIENCY AUDIT

## Woodhall Spa Golf Club

Produced on Behalf of The R&A, EGU and GUW

JANUARY 2010

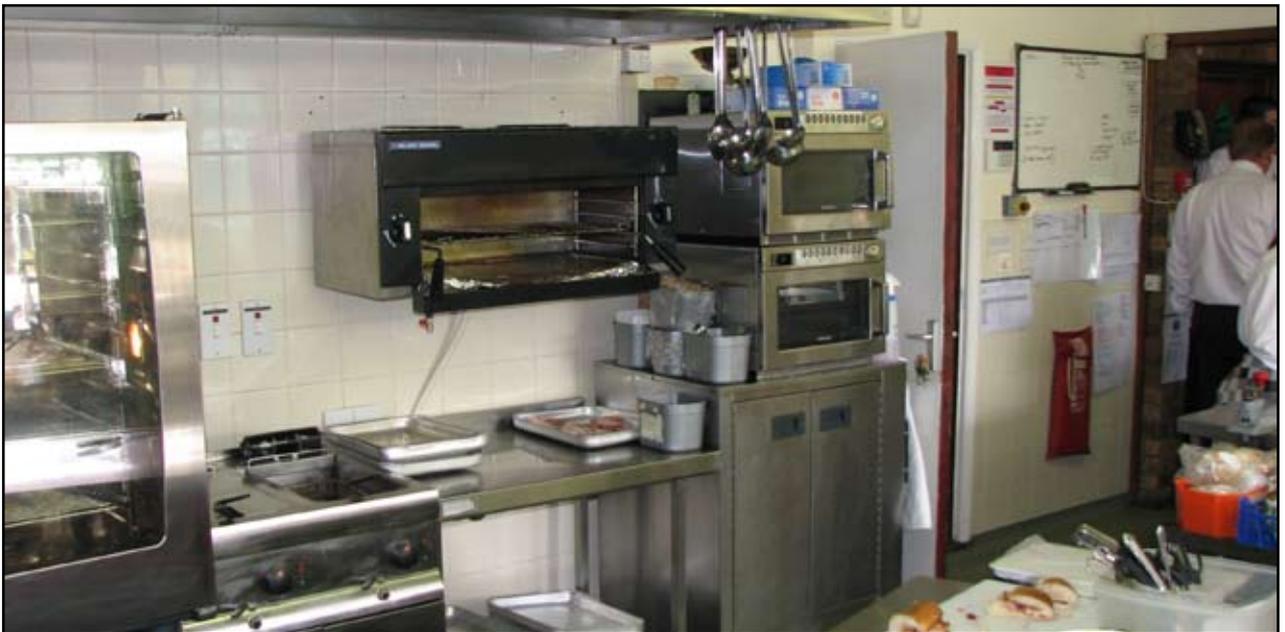
It is, of course, essential that appliances such as fridges and freezers are left on 24 hours a day and whilst there can be no compromise with operating times, it should be recognised that new versions of these appliances will be considerably more energy efficient than those aged five years or more. This comment applies to all equipment within the kitchens at Woodhall Spa and is perhaps most applicable to the club's washing machine that appeared to be in excess of 20 years old.

The kitchen at Woodhall Spa Golf Club leads to a network of side offices. During STRI's visit to the club the general observations made in this area were that lights were left on in many of the storerooms and side offices when vacant and of particular note was the radiator in the staff locker room (a room which is only briefly utilised each day) which was constantly delivering heat and maintaining the room at an uncomfortable temperature. In addition to this, the food storage room adjacent to the staff locker room was being air conditioned and kept at a very low temperature. Only an ill-fitting wooden door separated the two rooms and, as such, the radiator in the staff locker room and the air conditioning unit in the food storage room were competing with each other and therefore demanding more energy.

Radiators were also found to be left on in a number of the offices to the back of the kitchen area and it was also noted that a number of spider burners were left running throughout the day rather than being turned off and relit when required.

Issue	Solution
Lights on when room unoccupied	Motion sensor / signage / introduce "light monitor" personnel.
Equipment left on or on-standby when not in use	Turn equipment off when not in use. Employ "switch me off" stickers as reminders
Some appliances are dated and consume large amounts of power	Replace ageing appliances with new energy efficient models.
Heating on when rooms unoccupied and during periods of hot weather	Regularly monitor and adjust heating settings to meet the minimum needs required. Give someone the responsibility of heating monitor.
Food storage room air conditioned yet adjacent to over - heated locker room.	Fit better insulated door between the two rooms and turn heating and air conditioning down to minimum required levels

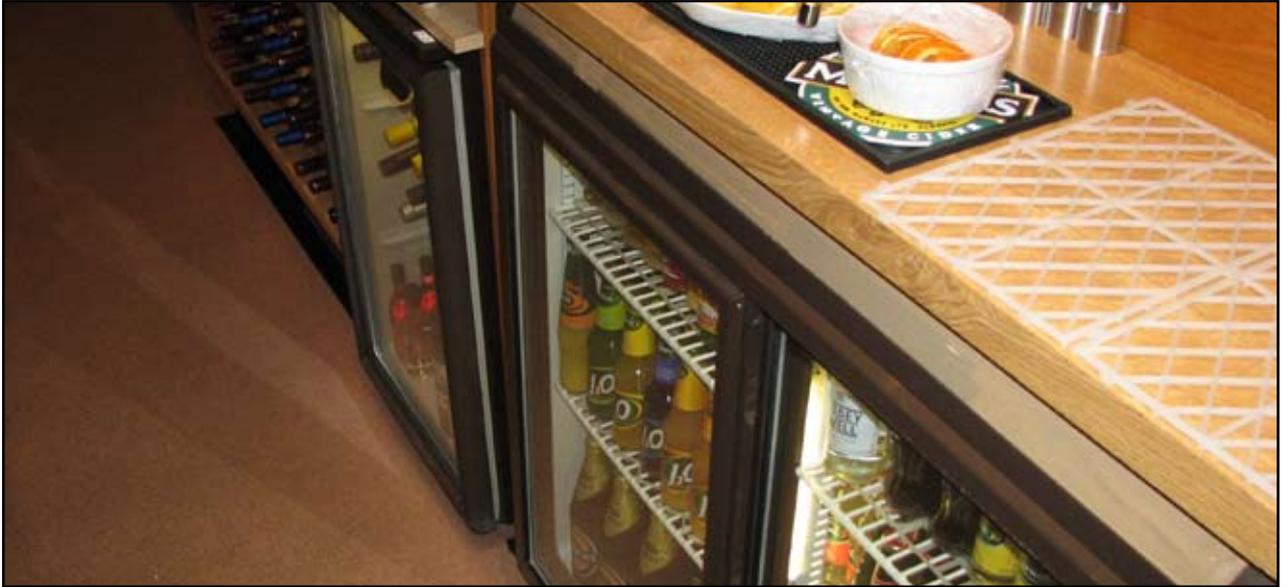
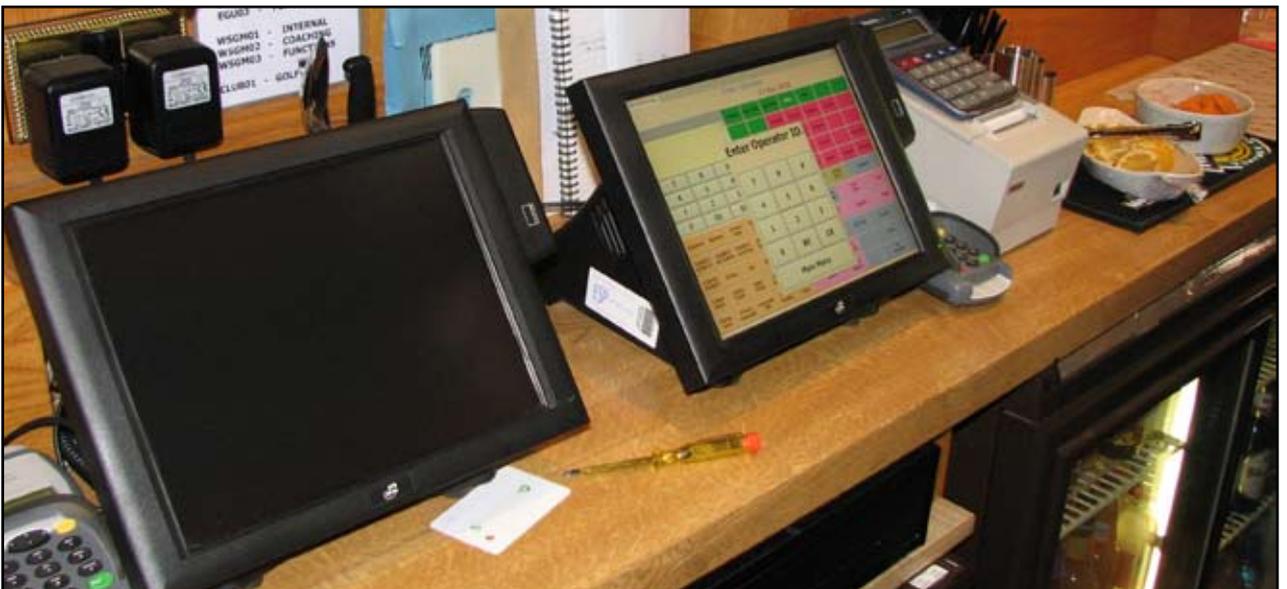
There are a total of four fridges within the bar and beer cellar area plus a main beer cooler unit which requires a constant 418.3 watts of electricity. It is presumed the bottle fridges are left on overnight. There is potential to fit timers to the fridges which will allow them to be off during the night (between perhaps 12am and 7am) yet back on early enough to ensure drinks are cold in time for bar opening. It is estimated that this would result in a saving of approximately £40 per year.

The glass washer within the bar area demands the largest amount of electricity in this area at 2.85 kW, however this appliance is only intermittently used.

In addition to natural light from the skylights, the bar area is lit by 14 halogen spot lights estimated to be costing the club £270 per year. Replacing these with low energy LED bulbs would reduce this figure ten-fold.

All electrical equipment that is only required during opening hours, including tills, Sky box, card reader and receipt printers should be switched off at the mains when not in use. To highlight the cost of such appliances, the two tills, if left switch on 24 hours a day, cost the club the not inconsiderable sum of £367.14 per year.

Issue	Solution
Equipment left on or on-standby when not in use	Turn equipment off when not in use. Employ "switch me off" stickers as reminders
Natural light sources could function more efficiently	Clean skylights regularly
Halogen spotlights currently fitted	Fit energy efficient bulbs
Bottle fridges left on 24 hours a day	Fit timers to ensure fridges are only on when required.

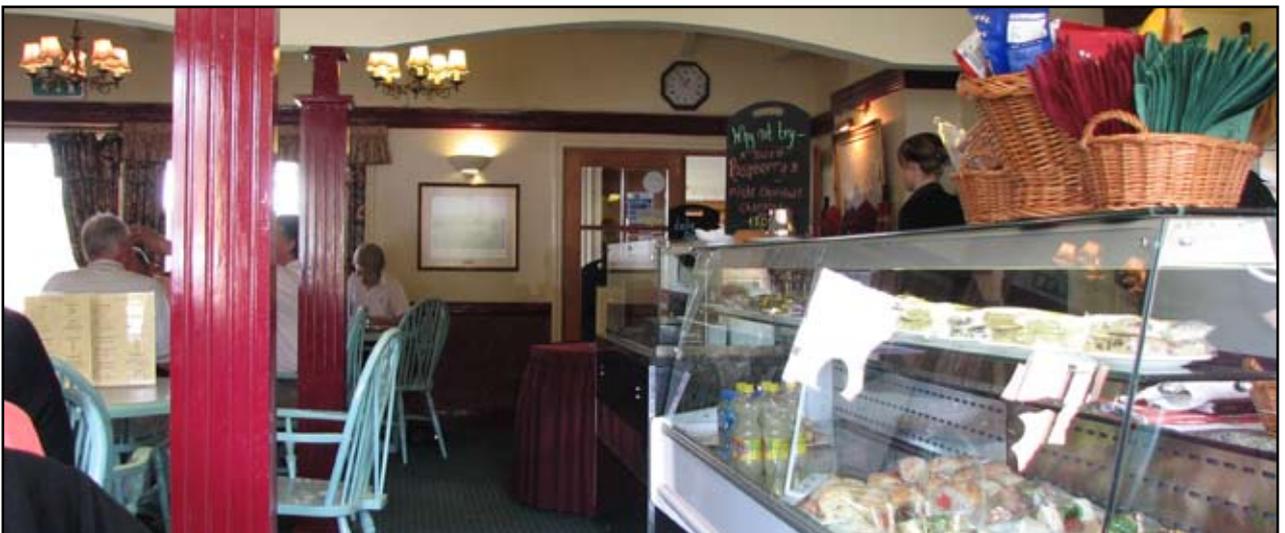
Table 3 (Appendix 2) lists all equipment within Dining Area 1. This dining area sees frequent use during lunchtime hours however is often empty at other times. Lights were noted to be left on at all times during hours of business. This practice could be changed by introducing "switch lights off" signage or fitting motion sensors. It was also noted that plenty of natural light was available as the room supports a total of five good sized windows to both sides of the building. As such it may be the case that artificial light is not required at all during daylight hours in summer. At the very least fewer lights should be used during these periods – an option already available to the club thanks the flexible lighting controls in this room. The club have already installed a number of energy efficient compact fluorescent bulbs in the dining room. The next step will be to replace all remaining incandescent bulbs. Lighting in dining area 1 is currently estimated to be costing the club £725 per year. It is thought that there is considerable potential to reduce this figure.

A number of high energy appliances are used in the dining area including the "hot cupboard" which demands 2.2kW of electricity to function, a hot water boiler and display chiller. These appliances should only be on when necessary. The hot cupboard should only be required during peak meal times.

Issue	Solution
Lights on when room unoccupied	Motion sensor / signage / introduce "light monitor" personnel.
Equipment left on or on-standby when not in use	Turn equipment off when not in use. Employ "switch me off" stickers as reminders
Poor insulation	Investigate improving window, door and roof insulation.
Some inefficient light bulbs remain	Replace all incandescent bulbs with energy efficient varieties
All lights on during day despite good natural lighting	Fit light level sensors and utilise flexible lighting

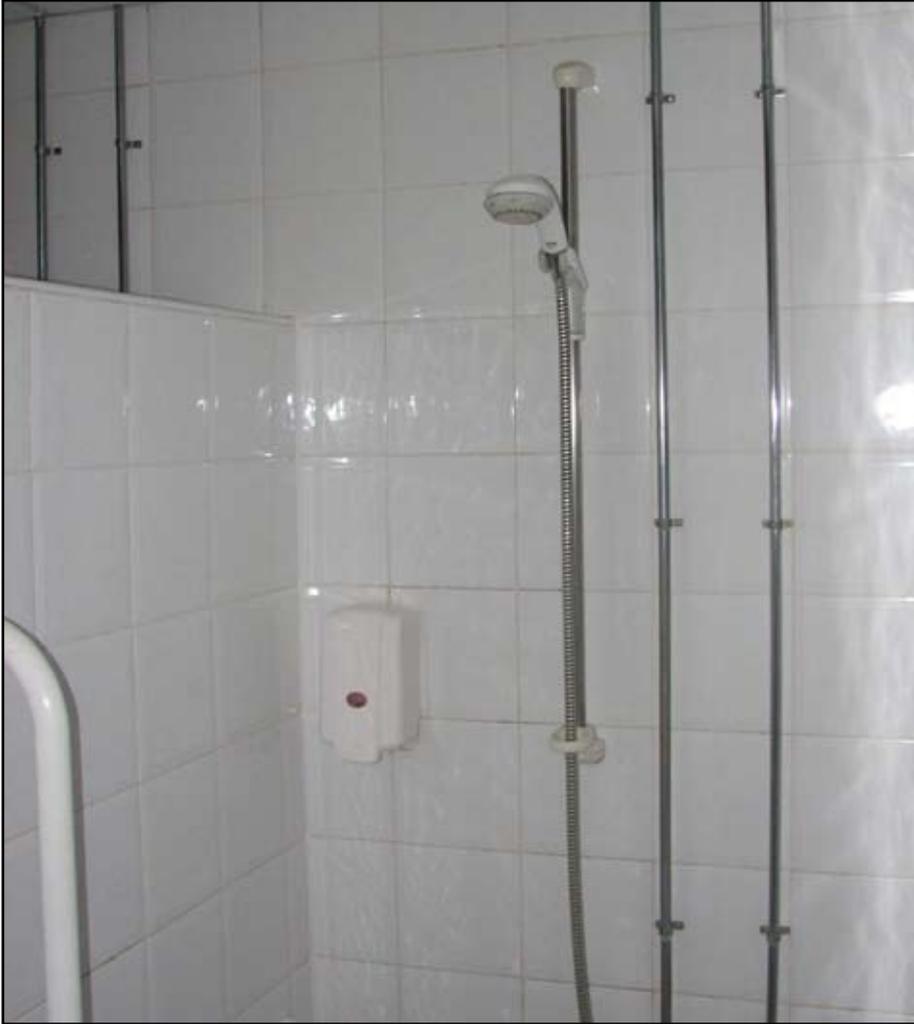
The drying rooms are a source of considerable energy use. It was noted that the drying rooms were in use at the time of STRI's visit despite the weather being hot and dry. The drying rooms should only be in use during periods of wet weather. The potential for energy saving here is significant.

The electric showers provided in both the ladies and gentlemen's locker consume a vast amount of energy and are estimated to be costing the club £3,028 per year. Highlighting this to the membership thorough signage and perhaps website notifications and encouraging users to keep the length of their showers to a minimum could significantly reduce the financial burden of these appliances.

Issue	Solution
Lights on when room unoccupied	Motion sensor / signage / introduce "light monitor" personnel.
Equipment left on or on-standby when not in use	Turn equipment off when not in use. Employ "switch me off" stickers as reminders
Poor insulation	Investigate improving window, door and roof insulation.
Some inefficient light bulbs remain	Replace all incandescent bulbs with energy efficient varieties
All lights on during day despite good natural lighting	Fit light level sensors and utilise flexible lighting
Paper towels, hand towels and hand dryers all available	Provide only energy efficient hand dryers. Use of hand towels = extensive energy use through washing operations.
Drying rooms demands considerable energy and is functioning all year round	Drying room should not be operational during periods of dry weather.
Showers are hugely energy demanding	Educate members and encourage minimal usage

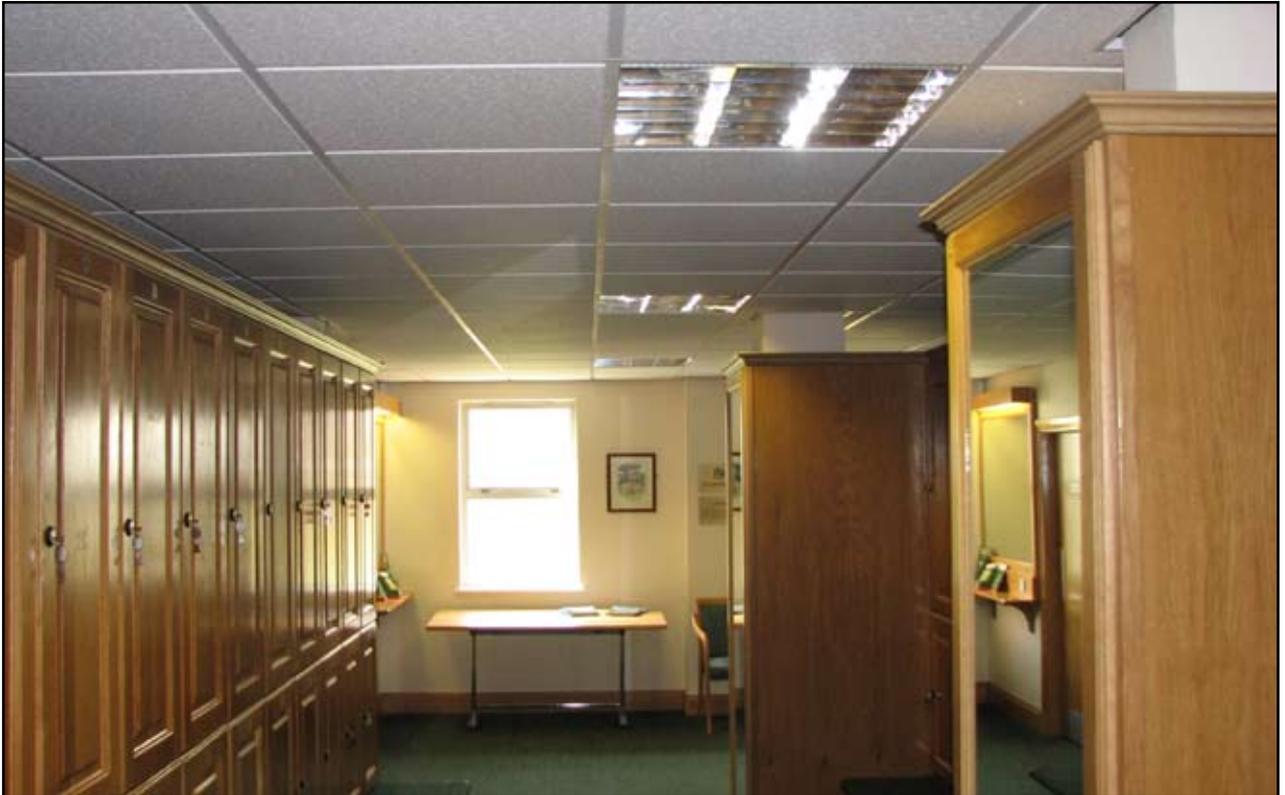
The new building has the benefit of double glazing, thereby vastly improving its insulating properties. It was still the case however that lights were left on when the room was vacant and heating was on at an unacceptably warm level. This was particularly noteworthy given the warm outdoor temperatures of the day. All thermostatic radiators were noted as being set to their maximum level.

Lighting above mirrors was also left on when not in use. Given the close proximity of the mirrors to windows these lights are unnecessary during daylight hours and should therefore be able to be activated independently of the main lights.

Issue	Solution
Lights on when room unoccupied	Motion sensor / signage / introduce "light monitor" personnel.
Lights above mirrors not required during daylight hours	Fit independent switches for mirror lights
Heating on at very high level	Turn heating off during warm periods. Set thermostat at lower level.

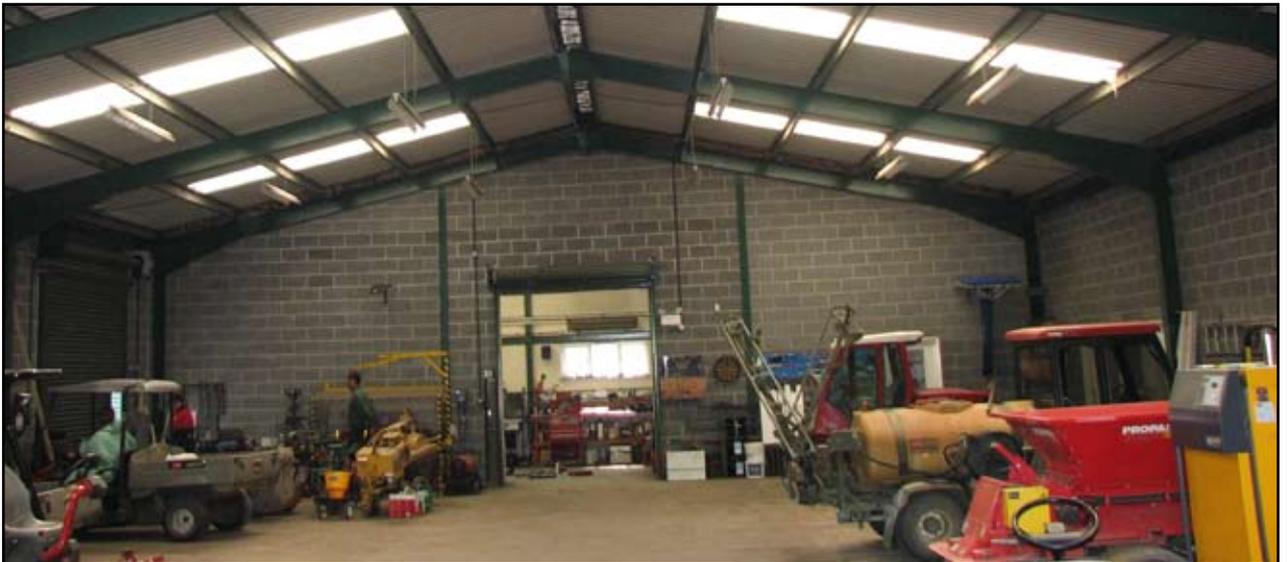
The compound is heated by a wood burning stove but also has central heating installed within office areas.

Lights have differential controls however lighting was noted as being left on in the kitchen and offices when vacant. Motion sensors would be appropriate for these areas.

Issue	Solution
Lighting left on in kitchen and offices when vacant	Fit motion sensors / "switch it off" signage. Assign responsibility
Timer fitted to water boiler yet set incorrectly	Set timers to ensure minimum amount of energy is utilised
Equipment in offices/kitchen left on standby when not in use	Ensure all equipment is switched off at mains when not required

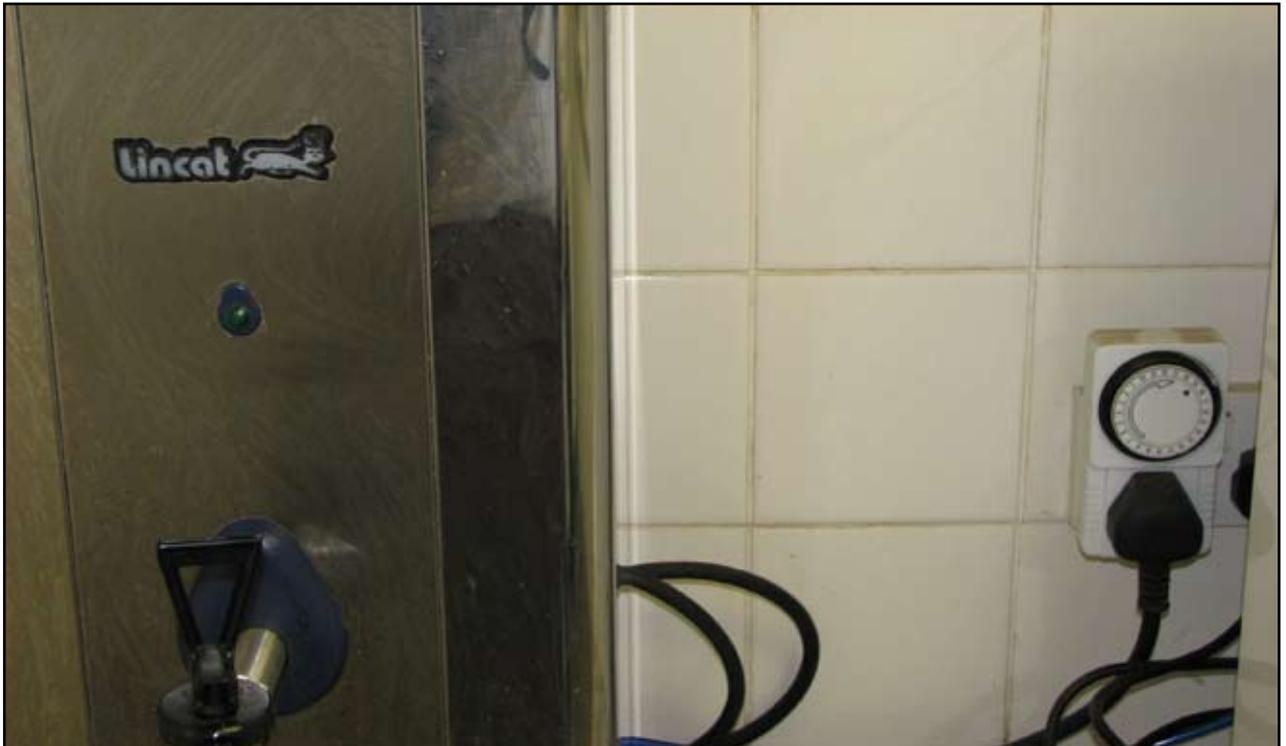
The kitchen area contains amongst other things two microwaves a dishwasher and two toasters. There is also a water boiler which was noted as being connected to a timer. This is a very positive initiative although it was noted that the timer was set to switch the boiler on at 2am – which it is felt is a little premature.

The offices contain a variety of electrical equipment which should not be left on / on standby when not in use. Given the nature of the greenstaff movements (i.e. much of the day is spent outside on the golf course), the policy should be to turn off all computers that are not required to power golf course systems (irrigation etc).
